Gingival Response to Crowns: A 3-Year Report

Omar El-Mowafy, BDS, PhD, FADM

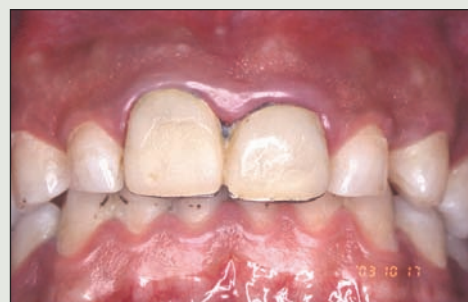
Figure 1: Facial view of the anterior teeth shows 2 porcelain-fused-to-metal crowns on the maxillary central incisors. The crowns have undergone incisal wear, which has revealed the metal backing. Partial loss of the glaze layer has resulted in a granular surface texture. The 2 crowns do not match in terms of either height or width. The gingival tissues are inflamed and hyperplastic because of the ill-fitting margins. The lateral incisors appear much smaller than the central incisors (contrary to what would usually be expected), which creates a lack of harmony in the set-up of the anterior teeth.

A 25-year-old otherwise healthy man presented with unsightly and failing porcelain-fused-to-metal crowns on his maxillary central incisors and asked the practitioner to improve their appearance (Fig. 1).

The gingival length of the crowns was mismatched by 2 mm, and 1 crown looked wider in mesiodistal dimension than the other. From the facial perspective, metal was evident at the incisal edges, perhaps because of wear. The crown margins were poorly fitted, and there was extensive hyperplasia and inflammation of the gingival tissues. The colour of the porcelain veneer was too yellow and did not match that of adjacent teeth, and the glaze layer was partially lost.

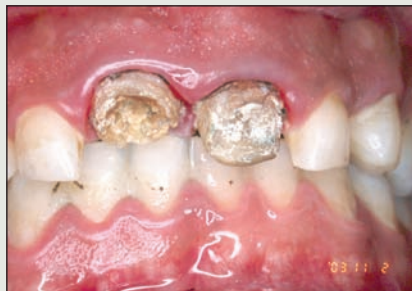
Figure 2: The 2 old crowns were sectioned and removed. When the crown was removed from tooth 11, the core became dislodged, so it was also removed.

Scaling and polishing was carried out to remove calculus and stain. When the 2 old crowns were removed, the core material on tooth 11 was also dislodged (**Fig. 2**). Gingivectomy was performed to increase the clinical crown length of tooth 21 to match that of tooth 11. Tooth 11 received a nonmetallic fibre post secured with resin cement and composite core build-up. As planned, diamond burs were used to re-prepare teeth 11 and 21 with a 1.2-mm finish line all around the shoulder. Similarly, teeth 12 and 22 were prepared to receive

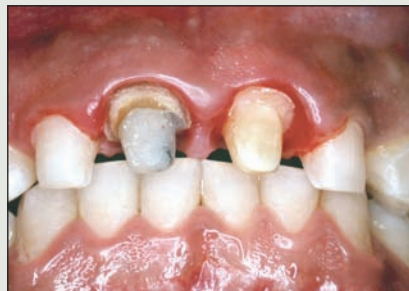
Figure 3: After scaling, gingivectomy was carried out to increase the clinical crown length of tooth 21 to match that of tooth 11. Tooth 11 was restored with a nonmetallic post and a composite core build-up and was then re-prepared to receive an all-porcelain crown with a wrap-around shoulder finish line. Tooth 21 underwent the same re-preparation. Teeth 12 and 22 were prepared to receive porcelain veneers.

porcelain veneers (**Fig. 3**). Double retraction cords were placed around the crown margins of teeth 11 and 21 before use of a silicon impression material and a stock tray to take an impression. Tooth shade was determined in daylight with a shade guide. Porcelain crowns with aluminum oxide core were made for teeth 11 and 21, with matching feldspathic porcelain veneers for teeth 12 and 22 (**Figs. 4 and 5**). The 2 crowns were first secured with a resin cement that had performed well under laboratory testing conditions.⁴ The try-in paste of the resin cement was tested with the 2 veneers to determine the optimum colour match, and the 2 veneers were then cemented with the appropriately shaded cement. Although some manufacturers of all-porcelain crowns are highly confident

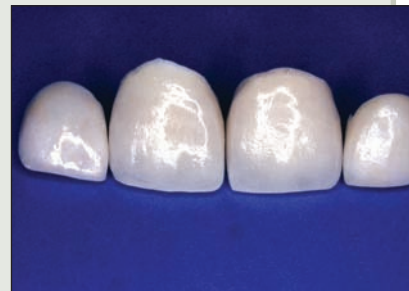
Figure 4: The 2 all-porcelain crowns and the 2 porcelain veneers as received from the laboratory.

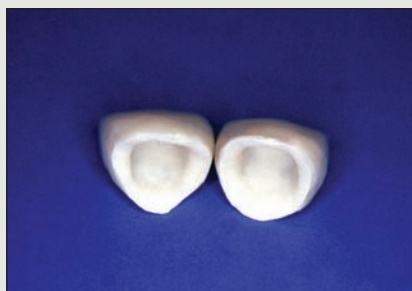
Figure 5: The fitted surfaces of the 2 porcelain crowns. The core was made of an aluminum oxide-based porcelain.

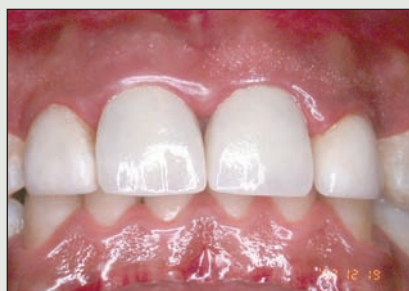
Figure 6: Immediate postoperative view following cementation of the 2 porcelain crowns and the 2 porcelain veneers. Although there is significant improvement in tooth esthetics at this point, the gingival tissue has not completely recovered, and there is evidence of gingival hyperplasia.

of the strength of their products, to the point that they do not recommend the use of resin cement for cementation, research has shown that microleakage occurs when resin cement is not used, and this may cause recurrent caries over the long term.⁵ Facial photography of the restored teeth (Fig. 6) immediately after the procedure showed significant improvement in the esthetics of the teeth relative to the preoperative view, but the gingival tissues had not yet completely recovered and there was evidence of some remaining gingival hyperplasia. A facial view obtained 3 years after placement of the crowns and the porcelain veneers (Figs. 7–9) provided evidence of proper healing of the gingival tissue between teeth 11 and 21 and proper shaping of the interdental papilla. A lingual view obtained at the same time showed ideal shaping of the interdental papilla between teeth 11 and 21 (Fig. 10).

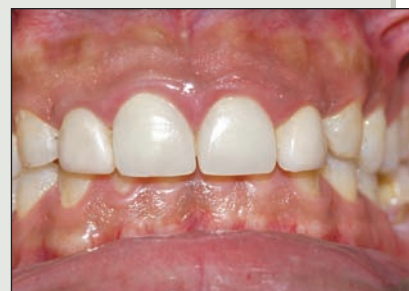
Figure 7: Postoperative view 3 years after placement of the crowns and the porcelain veneers. There is better healing of the gingival tissues and proper shaping of the interdental papilla between teeth 11 and 12.

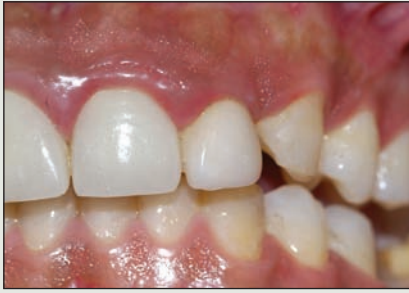
Figure 8: Close up view of the left side.

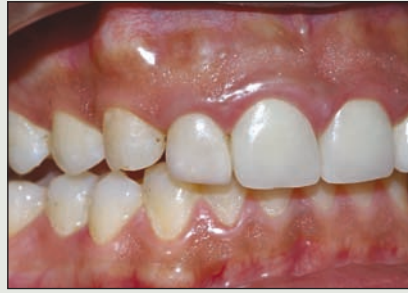
Figure 9: Close up view of the right side.

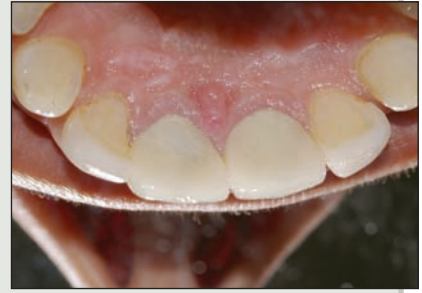
Figure 10: Lingual view shows shaping of the interdental papilla between teeth 11 and 21 is ideal.
