# Use of Porcelain Veneers, Crowns and an Implant to Resolve an Esthetic Problem

Omar El-Mowafy, BDS, PhD, FADM

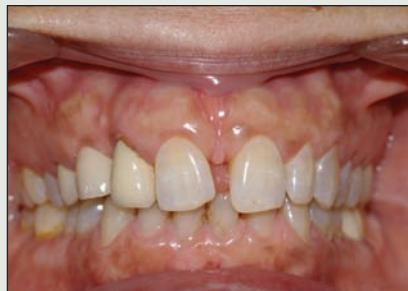
**Figure 1:** Intraoral view of a 51-year-old woman shows excessive diastema between the maxillary central incisors. The maxillary right central incisor has an incisal fracture at the mesial side and appears mesially tilted. The maxillary right lateral incisor is acting as an abutment for a fixed partial denture (FPD).

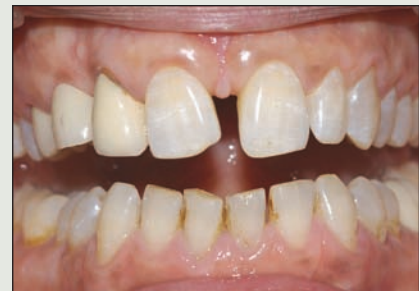
A 51-year-old woman who worked as a company sales representative was concerned about the deteriorating condition of her anterior teeth. On presentation, the appearance of her anterior teeth was less than ideal, and she requested treatment to improve the situation. Her medical history was non-contributory, but intraoral examination revealed excessive diastema between the maxillary central incisors (Fig. 1). The maxillary right central incisor had an incisal edge fracture at the mesial side and appeared mesially tilted. The maxillary right lateral incisor was acting as an abutment for a fixed partial denture (FPD). The retainer on this tooth was out of ideal positioning, and its colour did not match that of the adjacent teeth, perhaps because of opacity of the underlying metallic core (Fig. 2). The maxillary

**Figure 2:** The retainer on the maxillary right lateral incisor is out of ideal positioning, and the colour of the tooth does not match that of adjacent teeth. In the open position, the fracture on the incisal edge of the maxillary central incisor is more obvious. Staining of the lower incisors adds to the esthetic problem.

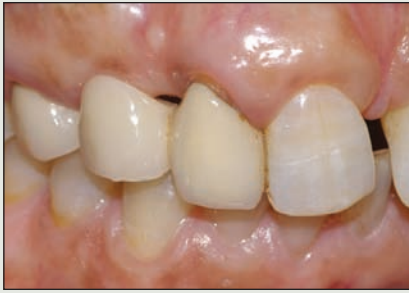
right canine was missing, and the pontic component of the 3-unit FPD that replaced it looked shorter than the lateral incisor and had a flattened incisal edge (Fig. 3). Further examination of the maxillary left anterior side revealed that the 3 anterior teeth were discoloured and the incisal edge of the central incisor was worn down at a slant (Fig. 4).

**Figure 3:** Close-up view of the maxillary right side. The canine, which is the pontic part of a 3-unit FPD, appears significantly shorter than the lateral incisor and has a flattened incisal edge.

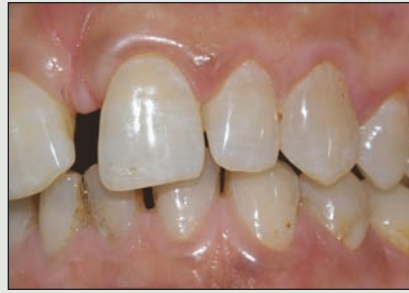
**Figure 4:** Close-up view of the maxillary left anterior side. The teeth are discoloured, and the incisal edge of the central incisor is worn down at a slant.

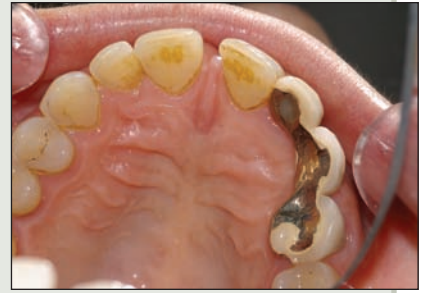
Lingual examination revealed the unsightly appearance of the metallic framework of the 3-unit porcelain-fused-to-metal FPD (Fig. 5). Prior endodontic treatment of the maxillary lateral incisor had been performed through the FPD retainer and the access opening had been sealed with resin composite. Part of the veneering porcelain on the distal aspect of the premolar retainer had fractured, and the remaining anterior teeth had dark extrinsic staining.

**Figure 5:** Lingual view of the maxillary anterior area. The lingual aspect of the 3-unit FPD shows the unsightly appearance of the metallic framework. Prior endodontic treatment of the maxillary lateral incisor had been performed through the FPD retainer, and the access opening had been sealed with resin composite. In addition, part of the veneering porcelain on the distal aspect of the retainer on the first premolar had fractured.

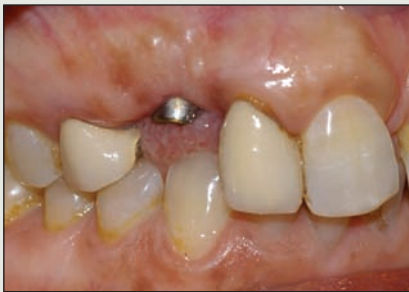
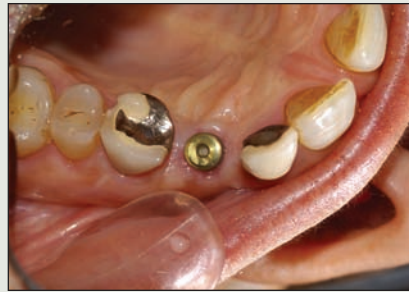
**Figure 6:** The pontic of the FPD was severed, and an implant was inserted into the space. This view shows the healing cap.

**Figure 7:** The retainers of the FPD were left in place on the maxillary lateral incisor and the first premolar throughout the healing period for the inserted implant.

The FPD pontic was severed, and an implant (NobelReplace Straight Groovy, Nobel Biocare, Gothenburg, Sweden) was inserted into the maxillary right canine location (Figs. 6 and 7). After healing was complete, a new maxillary stone model was made and a diagnostic wax-up constructed. The diagnostic wax-up was then duplicated in stone (Fig. 8). This stone model was used to show the patient the expected final shape of the teeth. It was also used for fabrication of a matrix to be used for making provisional restorations.

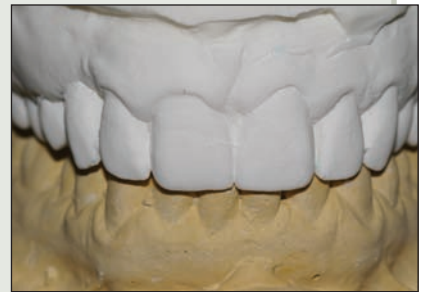
**Figure 8:** A diagnostic wax-up was made and duplicated in stone. The duplicate stone model was used for fabrication of a clear matrix with a vacuum moulding machine.

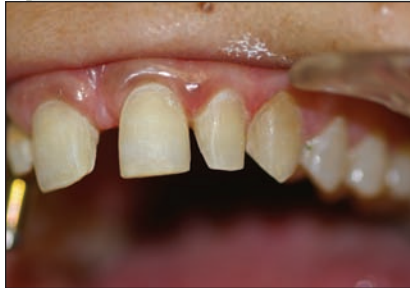
**Figure 9:** Four maxillary anterior teeth were prepared to receive porcelain veneers.

Following successful osseointegration of the implant, the FPD retainers on the maxillary right lateral incisor and the first premolar were removed. These 2 teeth were re-prepared to receive porcelain crowns, and the maxillary left central and lateral incisors and the maxillary left canine were prepared to receive porcelain veneers (Fig. 9). The healing cap was removed from the implant and a matching transfer coping was placed. A retraction cord was placed into the gingival sulci of the other prepared teeth to expose the preparation margins for accurate impression-taking (Fig. 10). A radiograph was obtained to ensure proper seating of the transfer coping onto the implant (Fig. 11). An impression was taken in a silicon material using the closed-tray technique, after which ceramic crowns with zirconium oxide cores and matching veneering porcelain were made for the lateral incisor

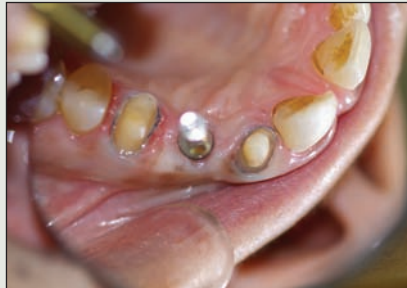
**Figure 10:** At the impression-taking stage, the implant healing cap was removed and the transfer coping secured in place. A retraction cord was placed in the sulci of the other prepared teeth.

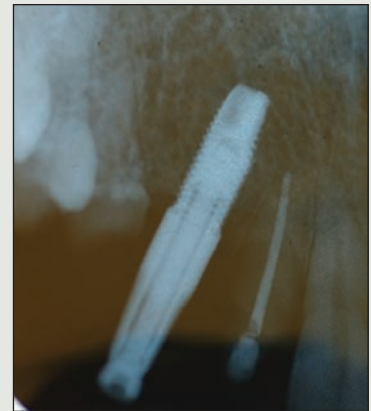
**Figure 11:** A periapical radiograph was obtained to ensure that the transfer coping had been properly seated onto the implant before the impression was taken.

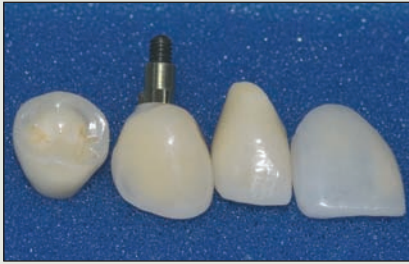
**Figure 12:** Two ceramic crowns and an implant-supported crown and porcelain veneer for the right maxillary central and lateral incisors, canine and first premolar. The difference in colour between the veneer and the crowns relates to the minimal thickness of the veneer.

and the first premolar (Procera Crown Zirconia, Nobel Biocare) (Fig. 12). An implant abutment made of zirconium oxide and matching the size of the inserted implant was veneered with matching porcelain (Procera Abutments, Nobel Biocare). For the remaining 4 prepared teeth, porcelain veneers were fabricated using matching feldspathic porcelain (Fig. 13).

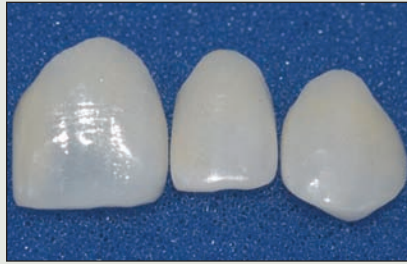
**Figure 13:** Porcelain veneers for the maxillary left central and lateral incisors and the left maxillary canine.

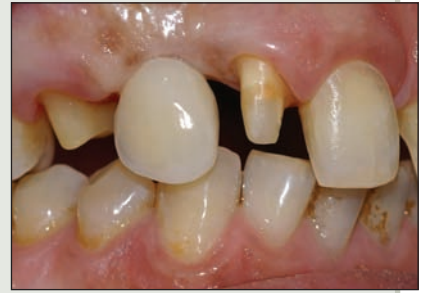
**Figure 14:** The implant-supported crown was the first to be inserted.

The implant-supported crown was the first restoration to be inserted (Fig. 14). After the crown was secured with a manual wrench, a radiograph was taken to ensure proper seating. The screw was then torqued to 35 N with a manual torque wrench (Nobel Biocare) (Fig. 15). The access hole was then sealed with a composite resin. The remaining 2 ceramic crowns were cemented with a dual-cured self-adhesive resin cement (Breeze, Pentron, Wallingford, Conn.) (Fig. 16), the ce-

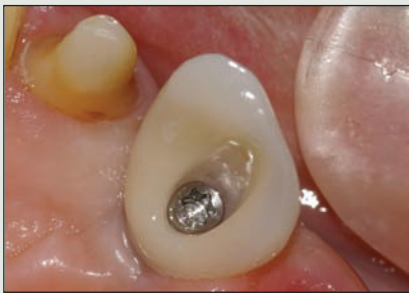
**Figure 15:** The implant screw was torqued with a manual torque wrench before the opening was closed with a composite resin.

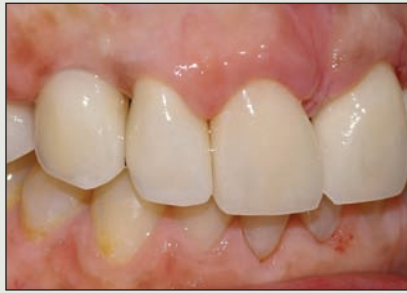
**Figure 16:** The ceramic crowns of the maxillary lateral incisor and first premolar were cemented with a resin cement. Restoration of the anatomic features of the teeth, as shown here, is key to achieving a natural, pleasing smile.

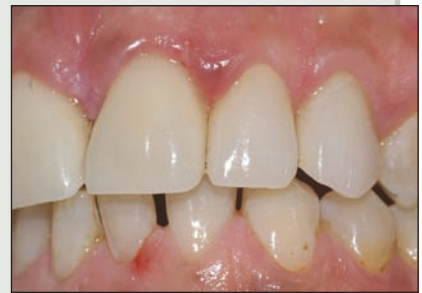
**Figure 17:** An appropriate shade of resin cement was selected and used to secure the 4 porcelain veneers.

ment of choice for ceramic restorations.<sup>6,7</sup> It was important to insert the 3 crowns first so that the final colour of all restorations could be established. The colour of the porcelain veneers could then be matched to the colour of the crowns by choosing an appropriate shade of resin cement (Fig. 17). A postoperative facial view (Fig. 18) shows how the colour of the veneers blends nicely with the colour of the crowns. The dimensional relation between the right central and lateral incisors is now ideal, the lateral tooth being shorter by 2 mm than the central incisor, unlike the preoperative situation (see Fig. 1), in which the 2 teeth were at the same level. However, it was impossible to completely close the diastema because of the excessive space between the 2 central incisors. Attempting to completely close the space would have made these 2 teeth appear wide, short and artificial. A lingual

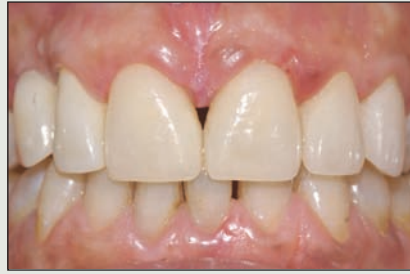
**Figure 18:** Immediate postoperative view. The colour of the veneers blends nicely with that of the crowns. This match was achieved by selecting the most appropriate shade of resin cement.

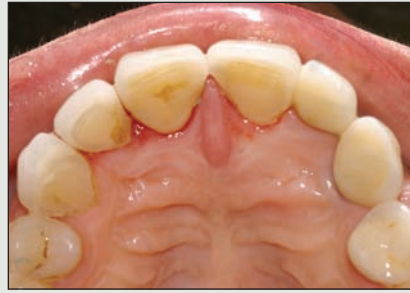
**Figure 19:** Lingual view of the maxillary anterior region. The appearance of the right side has been improved dramatically by using 3 crowns to replace the porcelain-fused-to-metal FPD.

postoperative view (**Fig. 19**) shows a dramatic improvement in the appearance of the teeth on the right side after replacement of the conventional porcelain-fused-to-metal FPD with 3 crowns.
