Comparison of Porcelain Veneers and Crowns for Resolving Esthetic Problems: Two Case Reports

Wafa El-Badrawy, BDS, MSc; Omar El-Mowafy, BDS, PhD, FADM

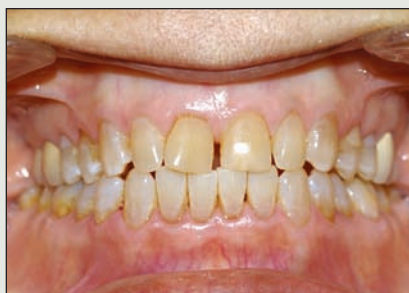
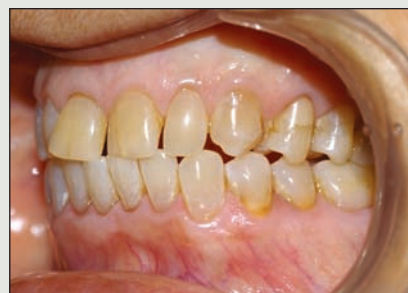
Figure 1a: Frontal view of the maxillary anterior teeth in case 1. The teeth are dark, there is a diastema between the 2 central incisors, and the right central incisor appears rotated and out of alignment.

Figure 1b: Left lateral view. Rotation and protrusion of the maxillary right central incisor are clearly visible.

were discoloured, spaced and malaligned (Figs. 1a and 1b). Although these problems had been present for several years, there had been recent deterioration, and the patient had decided to seek treatment to avoid further deterioration. The maxillary anterior teeth were darkened, with a diastema between the central incisors; in addition, the right central incisor appeared rotated and out of alignment. Vertical crack lines were visible at the centre of the facial surface of the 2 central incisors (Figs. 1a and 1b), but these marks were only superficial. At the time of the initial photographs, bleaching of the lower anterior teeth was in progress. Lingual examination showed some evidence of extrinsic staining, but the teeth were otherwise free of caries and restorations (Fig. 1c). Incisal wear was minimal and did not pose a serious concern.

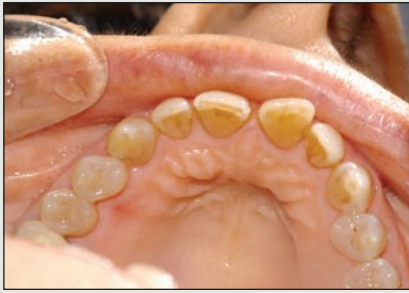
Figure 1c: Lingual aspect of the maxillary teeth. Although there is evidence of some extrinsic staining, the teeth are otherwise free of caries and restorations.

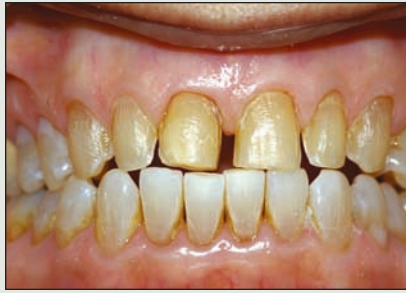
Figure 1d: Appearance of the maxillary anterior teeth after preparation for restoration with porcelain veneers. More reduction was required on the distal aspect of the facial surface of the maxillary right central incisor to create room for proper alignment of the veneer restorations.

Figure 1d shows the appearance of the teeth after preparation. After the impression was taken, 6 feldspathic porcelain veneers were made at a local dental laboratory (**Fig. 1e**). At the next visit, the prepared teeth were cleaned with a slurry of flour of pumice applied by means of a rubber cup. The prepared teeth surfaces were then etched with a phosphoric acid etchant, and a resin cement was used for cementation of the porcelain veneers. The diastema between the 2 central incisors was closed, the maxillary right central incisor had proper alignment, and the shade of the teeth was much lighter than the original (**Figs. 1f** and **1g**). The lingual view shows that the porcelain had to be extended interproximally between the 2 central incisors to close the diastema (**Fig. 1g**).

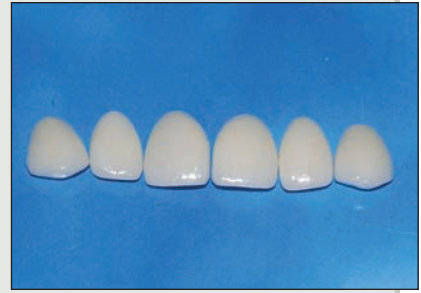
Figure 1e: Six porcelain veneers were fabricated in a laboratory to restore the maxillary anterior teeth.

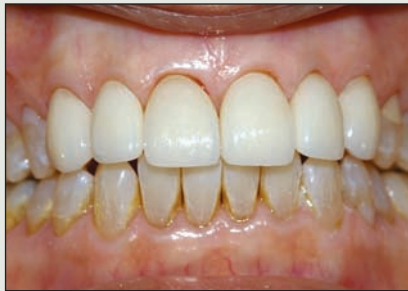
Figure 1f: Postoperative appearance of the maxillary anterior teeth. The diastema between the 2 central incisors has been closed, the maxillary right central incisor is now in proper alignment, and the shade of the teeth is much lighter than the original.

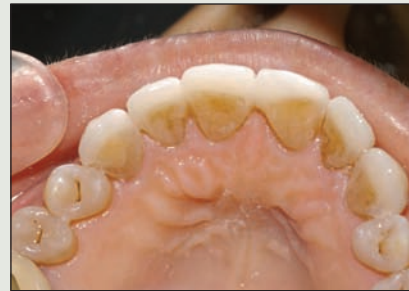
Figure 1g: Lingual view of the maxillary anterior teeth after cementation of the veneer restorations. This view shows how the porcelain had to be extended interproximally between the 2 central incisors to close the diastema.

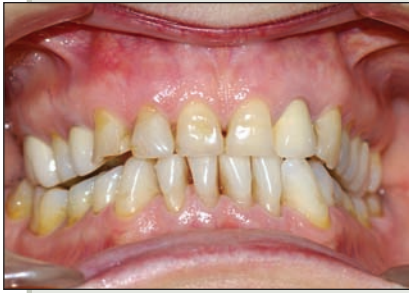
Figure 2a: Facial view of the maxillary anterior teeth in case 2. The middle third of both maxillary central incisors shows evidence of loss of enamel. The maxillary right lateral incisor has a cervical abrasion lesion, and the right canine has excessive incisal wear, along with cervical abrasion and mesial restoration.

A 52-year-old woman expressed a desire to improve the appearance of her anterior teeth (**Fig. 2a**). The 2 maxillary central incisors were discoloured and had areas of eroded enamel in the middle third. The maxillary right lateral incisor had a cervical abrasion lesion, and the right canine had excessive incisal wear, along with cervical abrasion and an old restoration at the mesial level. The maxillary left lateral incisor had been restored previously with a porcelain-fused-to-metal crown, which appeared too opaque. Examination of the lingual aspects of the maxillary anterior teeth revealed that the maxillary left lateral crown had a metal backing. The remaining 5 teeth showed evidence of severe wear and erosion of the enamel and extensive resin composite restorations (**Fig. 2b**). Following further analysis of study

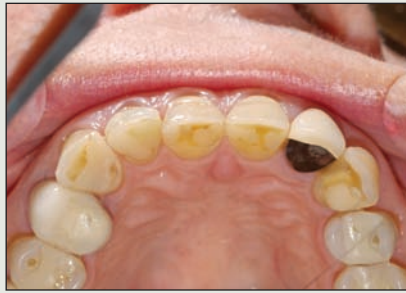
Figure 2b: Lingual appearance of the 6 maxillary anterior teeth. The maxillary left lateral has a porcelain-fused-to-metal crown, and the remaining 5 teeth show evidence of severe enamel wear and the presence of extensive restorations.

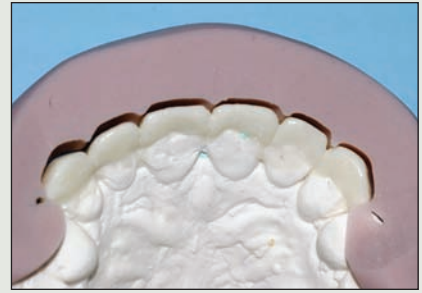
Figure 2c: The waxed-up model was used to fabricate a silicon reduction guide.

models, a duplicate stone model was waxed up according to the “most agreeable smile” guidelines.² More specifically, the maxillary central incisors and canines were waxed up to appear longer than the maxillary laterals.² The waxed-up model was used to discuss expected treatment outcomes with the patient. It was also used for fabrication of a silicon reduction guide (**Fig. 2c**). In addition, the waxed-up model was used for making a duplicate stone model that was subsequently used for fabrication of a soft clear matrix in a vacuum-forming machine. This was used in fabrication of the provisional crowns.

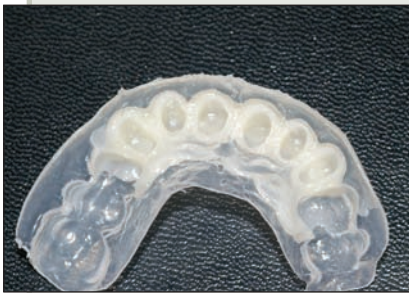
Figure 2d: A soft clear matrix was used to fabricate the provisional crowns.

previous carious lesions, wear and erosion, and full-coverage crowns would provide the support (bracing) necessary to maintain the structural integrity of the teeth under the forces of mastication. To optimize esthetics, nonmetallic crowns were selected. The maxillary left lateral incisor had previously undergone endodontic treatment, including restoration with a metallic post, and the nonmetallic crown had to be capable of concealing the metallic shade of the post. Therefore, crowns made of zirconium oxide cores and porcelain veneer were chosen. The literature contains good evidence of the reliability and survival of non-metallic crowns when used on anterior teeth.³⁻⁵ The 6 anterior teeth were prepared accordingly, with guidance from the silicon reduction guide. Provisional crowns were fabricated using the soft clear matrix (Fig. 2d) and were then cemented in place with temporary cement (Fig. 2e).

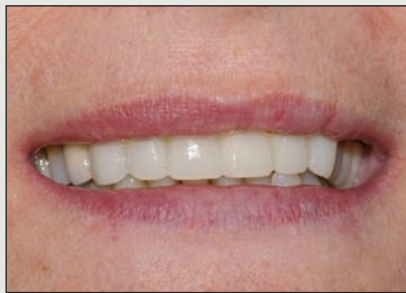
Figure 2e: Appearance of the anterior teeth after cementation of the temporary crowns. There has been a dramatic improvement in esthetic appearance.

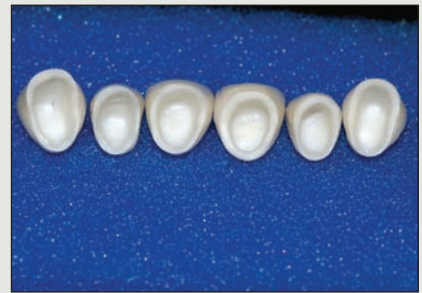
Figure 2f: The interior surfaces of the 6 ceramic crowns, which consisted of a zirconium oxide core veneered with porcelain.

Impressions were taken in a silicon material, and 6 ceramic crowns with zirconium oxide cores were fabricated (Fig. 2f). These were cemented with self-adhesive resin cement. By 2 weeks after cementation, the gingival tissues had recovered completely, and there was a dramatic improvement in esthetics (Figs. 2g and 2h).

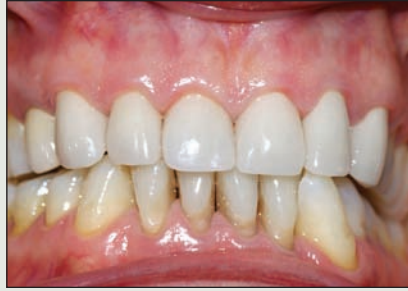
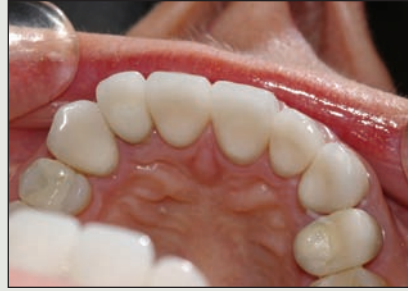
Figure 2g: Facial view of the 6 crowns 2 weeks postoperatively. The gingival tissues have rebounded to their original position and appear healthy, representing a positive response to the ceramic crowns.

Figure 2h: Lingual view of the maxillary anterior teeth 2 weeks postoperatively. This view also shows rebounding of the gingival tissues to their original position.
